# HOME INSPECTION REPORT

**123 Ave., Boise, ID 83000**

**Report Number:**  
2904-87

**Inspector:**  
Ryan Nielsen  
License Number - NACHI19022148

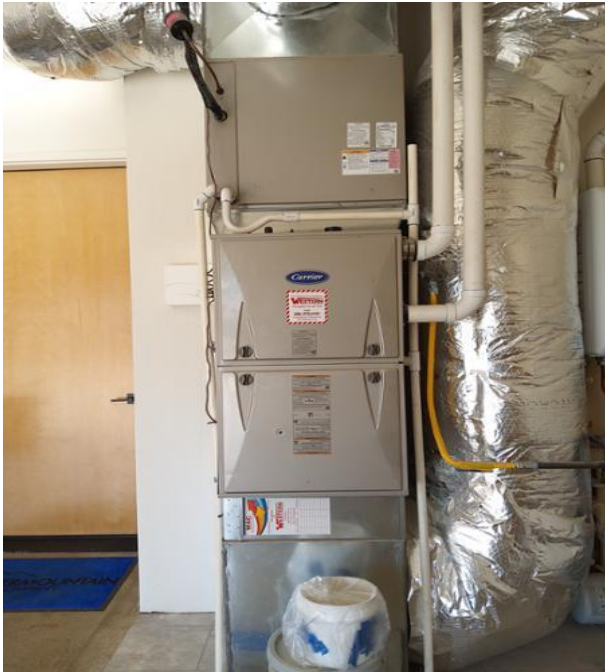
Observed possible incorrect filter installed in furnace unit. Suggest replace filter with correct one.

General view of the furnace.

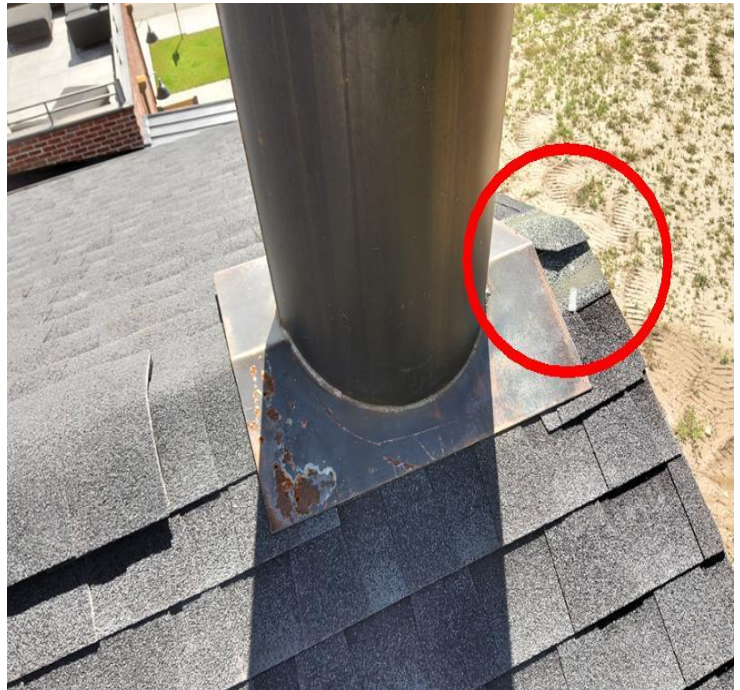
Observed missing ridge cap shingle at chimney. Suggest replace.

Photo to show the missing ridge cap shingle.

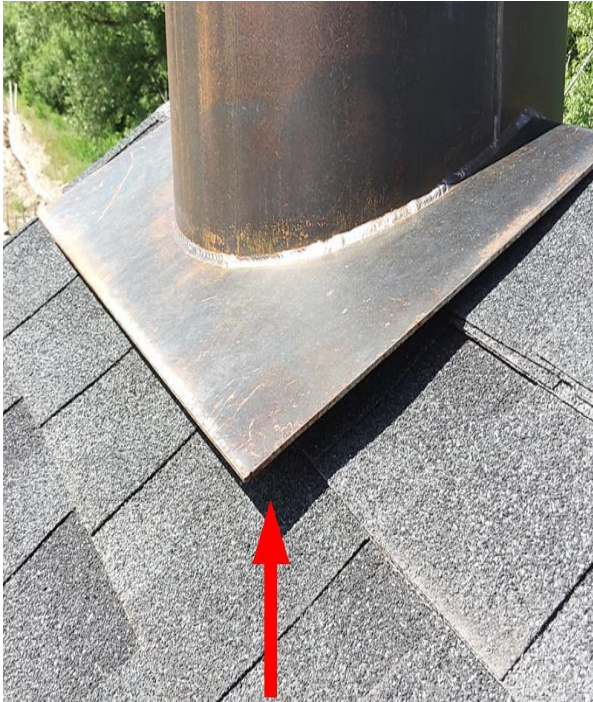
Suggest sealant around the base of chimney. Visible gap at flashing. Possible moisture or pest intrusion.

Photo to show location of the observed gap at flashing.

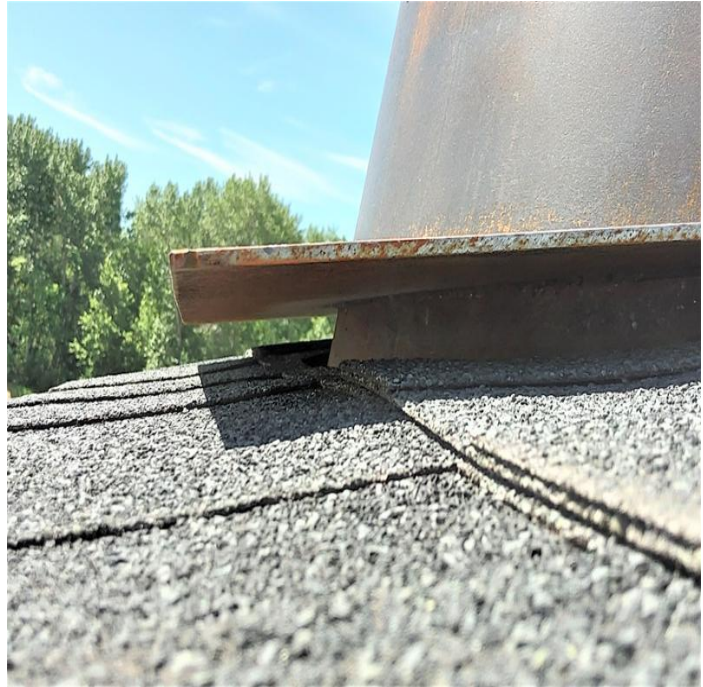
Photo to show the observed gap at chimney flashing. Suggest repair.

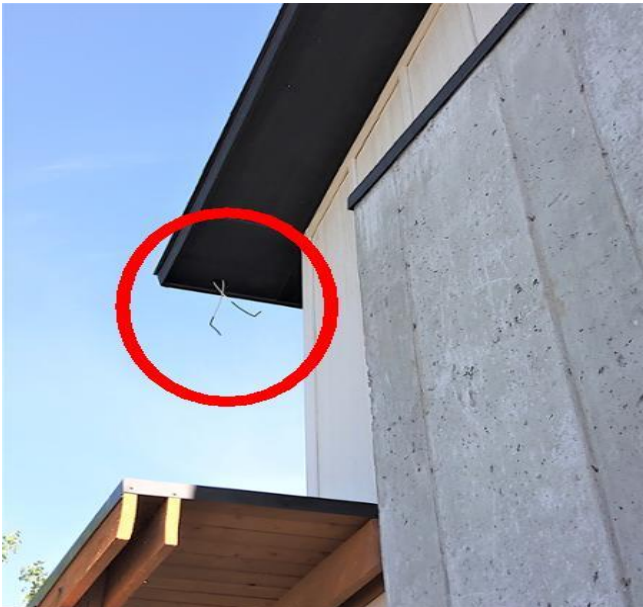
**Comments:** Observed wires hanging down from south west corner of second floor soffit. Above the back patio. Suggest complete installation or contain wires in a junction box.

Photo of show the observed exposed wires hanging. Suggest repair.

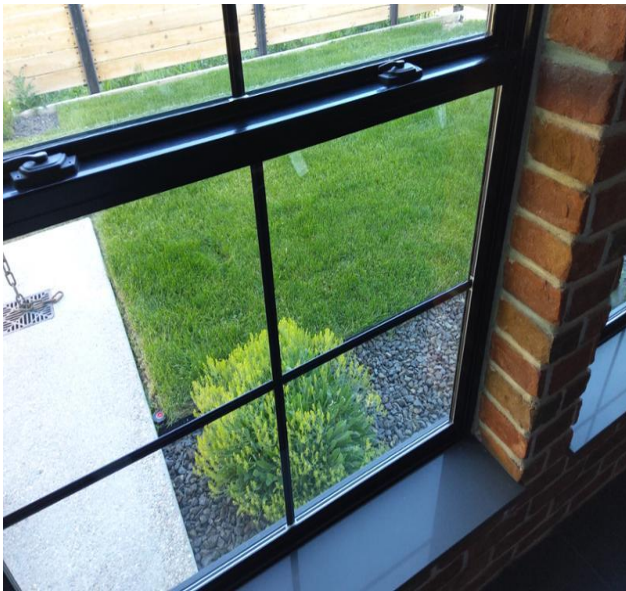
**Comments:** The windows appear to be in satisfactory condition.  
Observed missing window screens throughout the home. Suggest replace.

Photo to show example of the missing window screens at dining room.

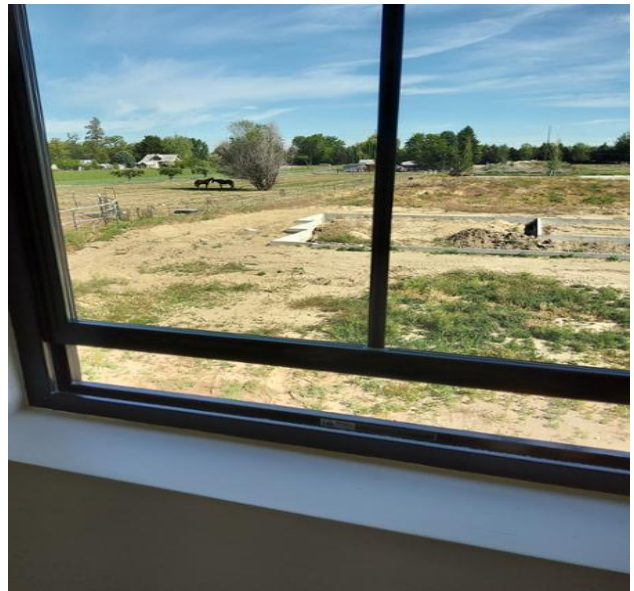
Observed missing window screen.

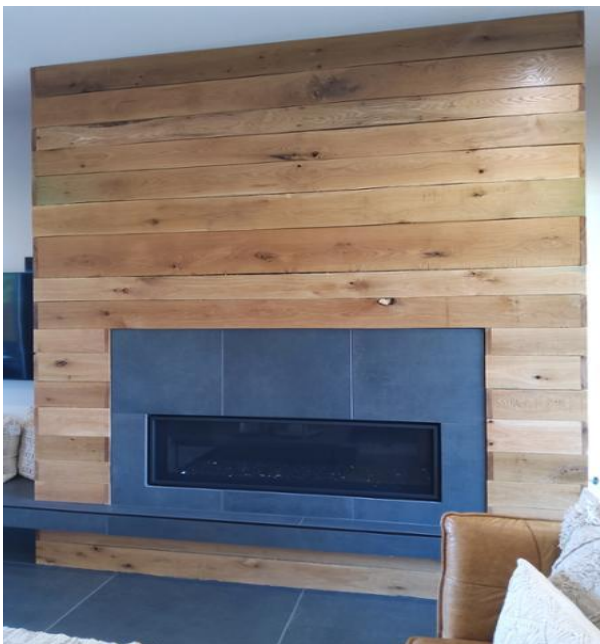
**Comments:** Unable to operate the fireplace. Observed open junction box at right side of fireplace. Possible incomplete installation. Suggest further inquiries from builder.

General view of the gas fireplace.

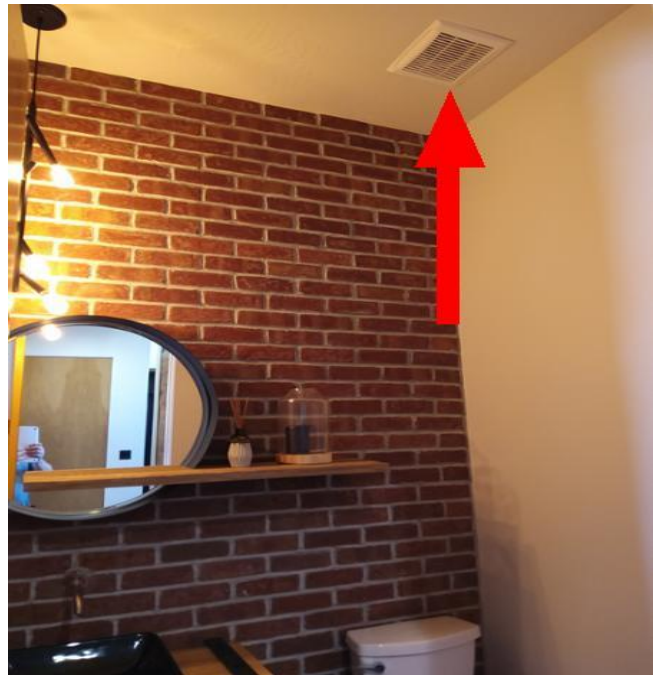
Exhaust fan at bathroom #3 was not operating. Recommend repair/replacement.

Photo to show the location of the exhaust fan. Did not work at time of inspection.
