# HOME INSPECTION REPORT

**123 Ave., Boise, ID 83000**

**Report Number:**  
2904-87

**Inspector:**  
Ryan Nielsen  
License Number - NACHI19022148

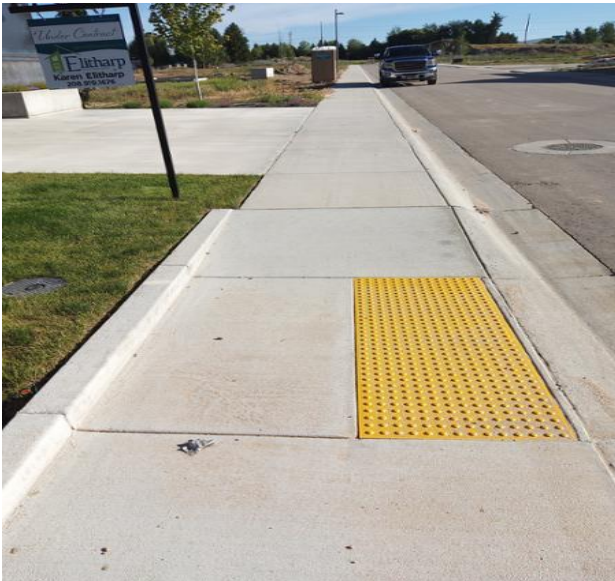
**Comments:** The front walkway appeared to be in satisfactory condition.

Photo to show the front sidewalk.

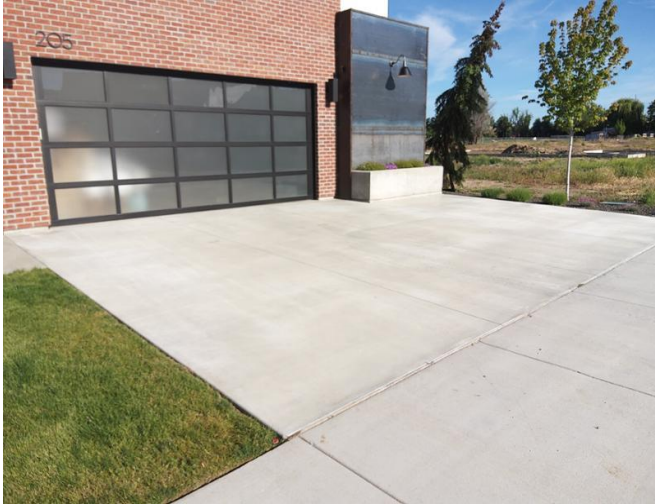
**Comments:** Driveway appears to be in satisfactory condition.

View of the concrete driveway.

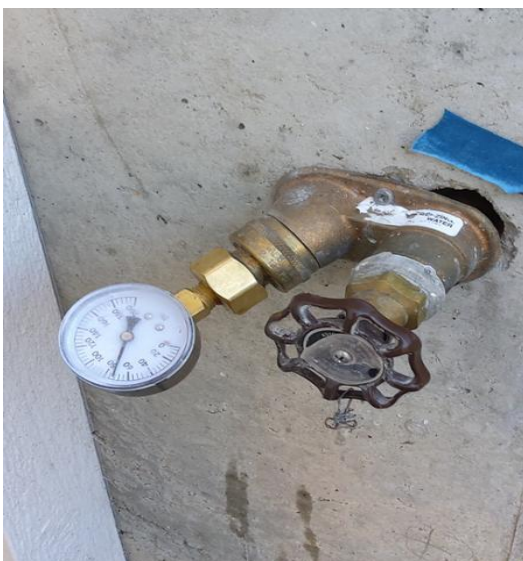
**Comments:** Normal or average water pressure is approximately 50-70 psi. The water pressure tested at the time of inspection was approximately 72 psi.

Photo to show the water pressure gauge reading approximately 72 psi.

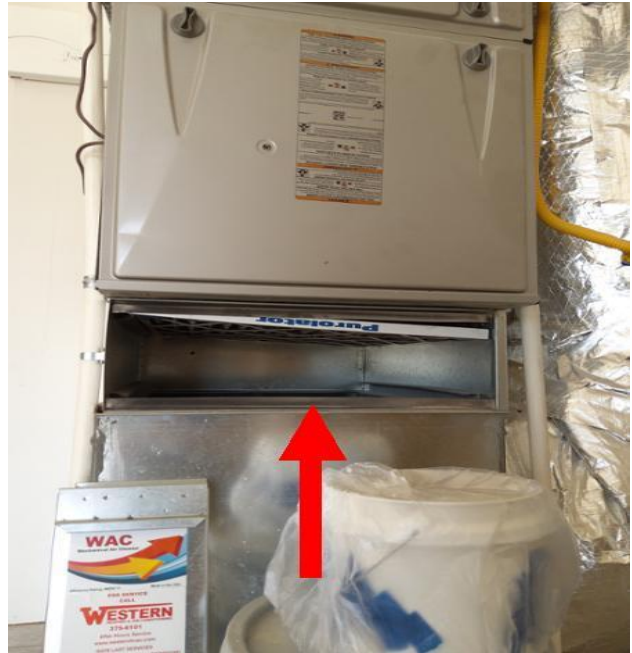
Observed possible incorrect filter installed in furnace unit. Suggest replace filter with correct one.

Photo to show the appearance of incorrect furnace filter installed.

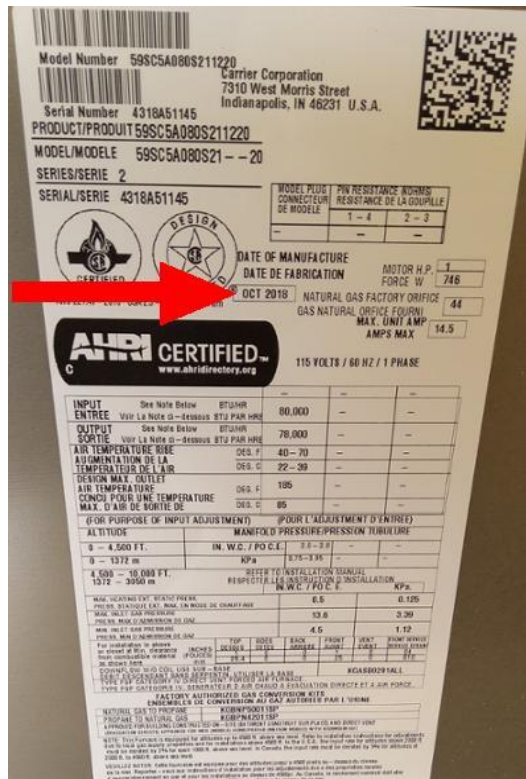
Photo of the manufacturer label. Arrow to indicate the manufacturer date. Oct. 2018

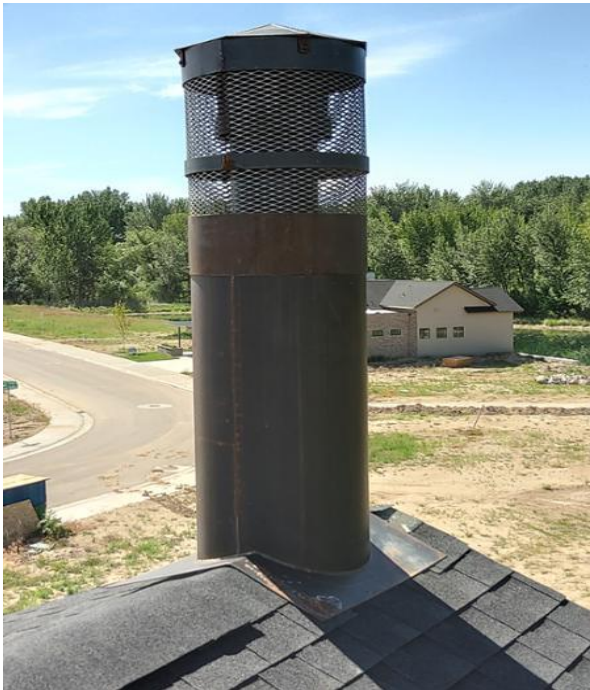
- Location(s):** The chimney of this house is located on the south west side of the home. Roof #1.
- Viewed From:** Roof
- Rain Cap/Spark Arrestor:** Yes
- Chase:** Metal
- Evidence of:** No apparent defects
- Flue:** Metal
- Evidence of:** No apparent defects
- Condition:** Marginal
- Comments:** Suggest sealant around the base of chimney. Visible gap at flashing. Possible moisture or pest intrusion. Observed missing ridge cap shingle at chimney. Suggest replace. See photos.

General view of the chimney.

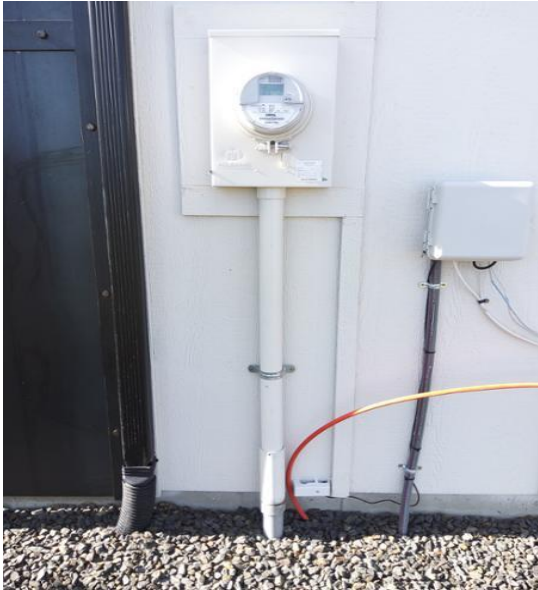
**Comments:** Service entry for this house appeared to be enacted and in satisfactory condition.

Photo to show the electrical service entry for the house.

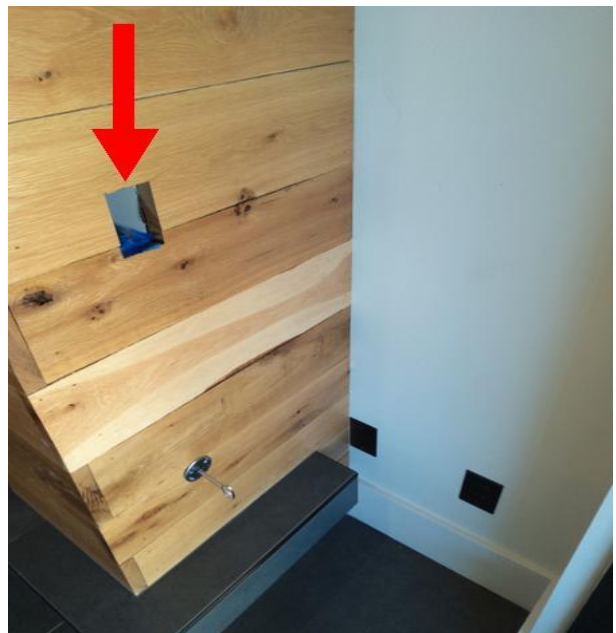
**Comments:** Unable to operate the fireplace. Observed open junction box at right side of fireplace. Possible incomplete installation. Suggest further inquiries from builder.

Photo to show the open junction box at right of fireplace.

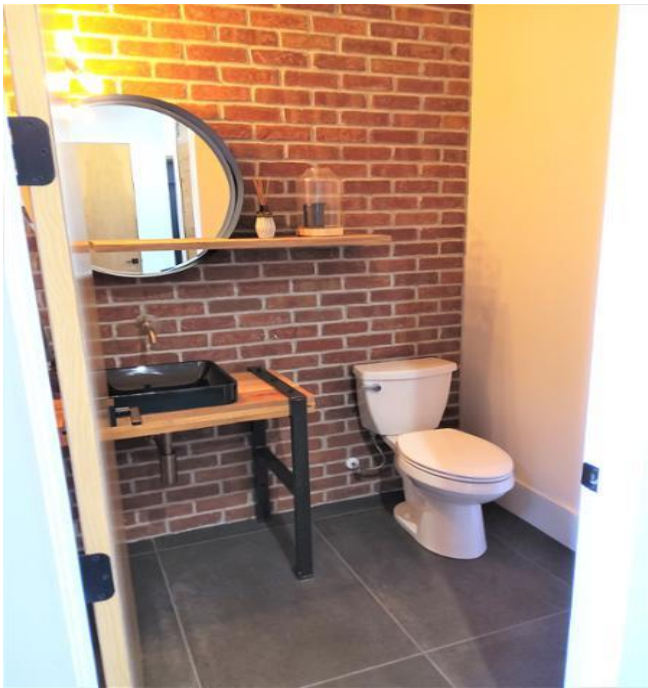
General photo of Bathroom #3.

<b>Location:</b>	Bathroom #3 is a half-bathroom located on the main floor between the Tech room and the kitchen.
<b>Sinks:</b>	Faucet leaks: No Pipes leak: No
<b>Tubs:</b>	N/A
<b>Showers:</b>	N/A
<b>Toilet:</b>	Bowl loose: No Operable: Yes
<b>Whirlpool:</b>	No
<b>Shower/Tub area:</b>	N/A
<b>Drainage:</b>	Satisfactory
<b>Water flow:</b>	Satisfactory
<b>Moisture stains present:</b>	No
<b>Doors:</b>	Satisfactory
<b>Window:</b>	None
<b>Receptacles present:</b>	Yes Operable: Yes
<b>GFCI:</b>	Yes Operable: Yes
<b>Open ground/Reverse polarity:</b>	No
<b>Heat source present:</b>	Yes
<b>Exhaust fan:</b>	Yes Operable: No
<b>Comments:</b>	Exhaust fan at bathroom #3 was not operating. Recommend repair/replacement.
