# HOME INSPECTION REPORT

**123 Ave., Boise, ID 83000**

**Report Number:**  
2904-87

**Inspector:**  
Ryan Nielsen  
License Number - NACHI19022148

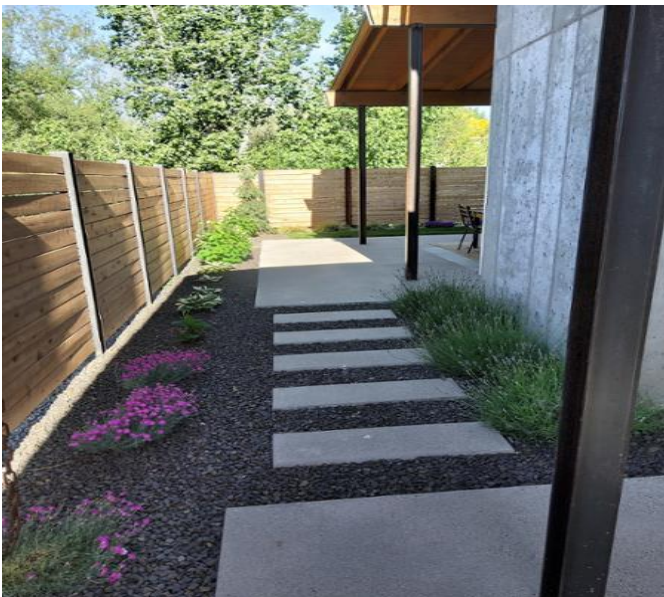
Photo to show the walk way leading to the back patio.

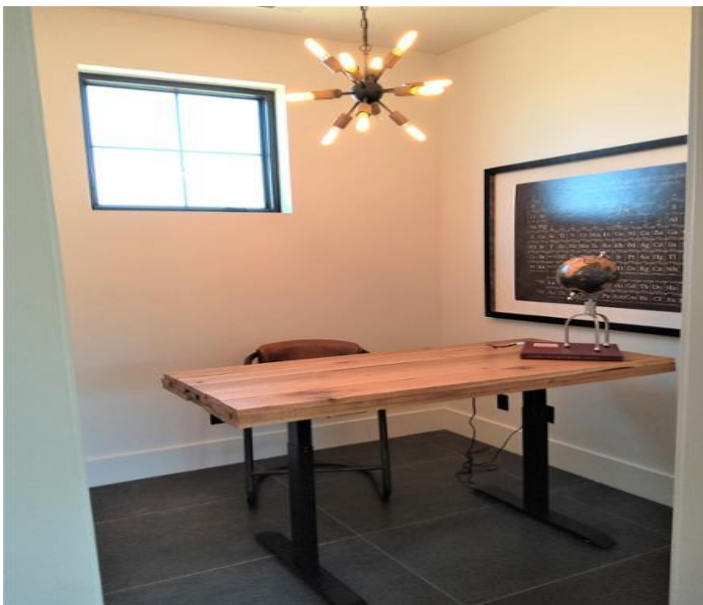
Photo of the Tech Room.

**Comments:** No issues were observed at the time of the inspection.

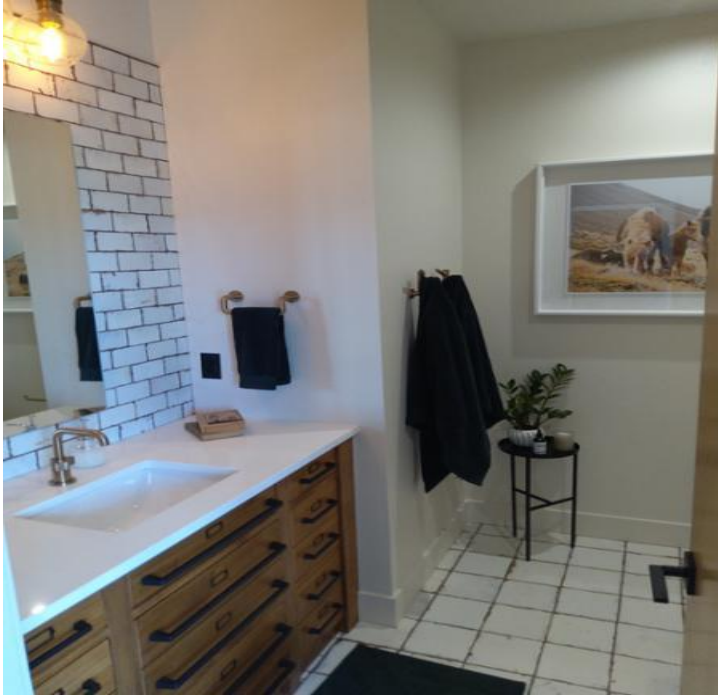
Photo of Bathroom #2.

<b>Location:</b>	Bathroom #2 is located on the 2nd floor, left of the stairs. Between Living room #2 and Bedroom #3.
<b>Sinks:</b>	Faucet leaks: No Pipes leak: No
<b>Tubs:</b>	Faucet leaks: No Pipes leak: Not Visible
<b>Showers:</b>	Faucet leaks: No Pipes leak: Not Visible
<b>Toilet:</b>	Bowl loose: No Operable: Yes
<b>Whirlpool:</b>	No
<b>Shower/Tub area:</b>	Fiberglass Condition: Satisfactory
<b>Drainage:</b>	Satisfactory
<b>Water flow:</b>	Satisfactory
<b>Moisture stains present:</b>	No
<b>Doors:</b>	Satisfactory
<b>Window:</b>	None
<b>Receptacles present:</b>	Yes Operable: Yes
<b>GFCI:</b>	Yes Operable: Yes
<b>Open ground/Reverse polarity:</b>	No
<b>Heat source present:</b>	Yes
<b>Exhaust fan:</b>	Yes Operable: Yes
<b>Comments:</b>	No issues observed at the time of inspection.

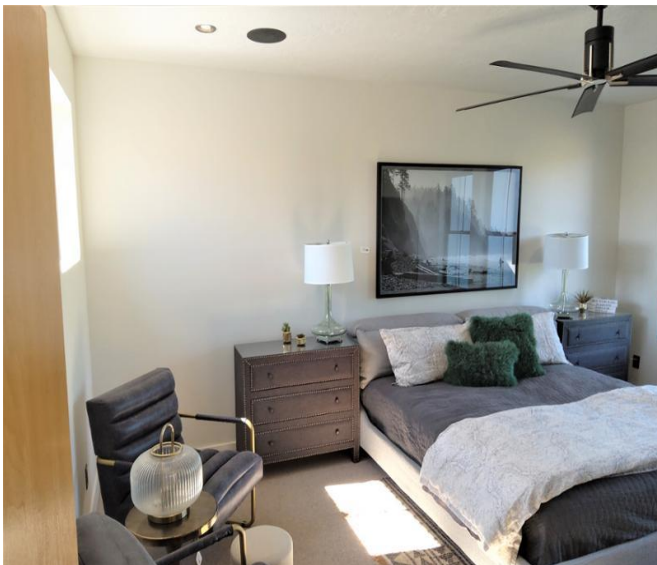
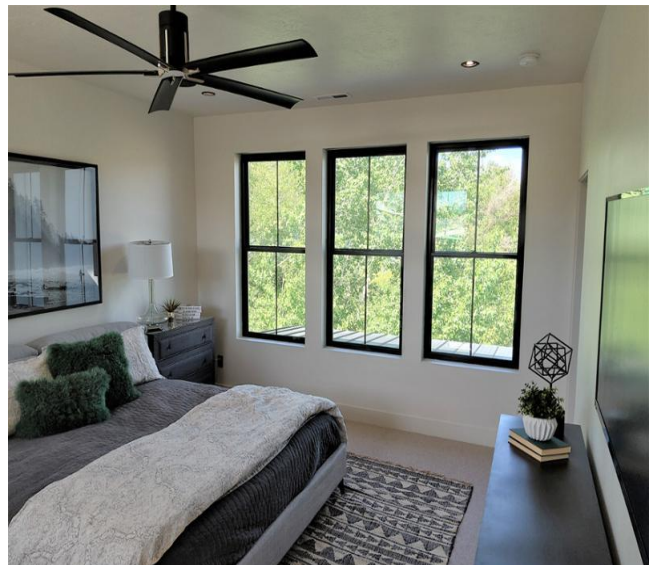
Photo of the Master Bedroom.

<b>Location:</b>	The Master bedroom is located at the south west side of the house.
<b>Type:</b>	MASTER BEDROOM
<b>Walls &amp; Ceiling:</b>	Satisfactory
<b>Moisture stains:</b>	No
<b>Floor:</b>	Satisfactory
<b>Ceiling fan:</b>	Satisfactory
<b>Electrical:</b>	Switches: Yes, Operable Receptacles: Yes, Operable Open ground/Reverse polarity: No
<b>Heating source present:</b>	Yes
<b>Bedroom Egress restricted:</b>	No
<b>Doors:</b>	Satisfactory
<b>Windows:</b>	Satisfactory
<b>Comments:</b>	No issues were observed or evaluated at time of inspection.

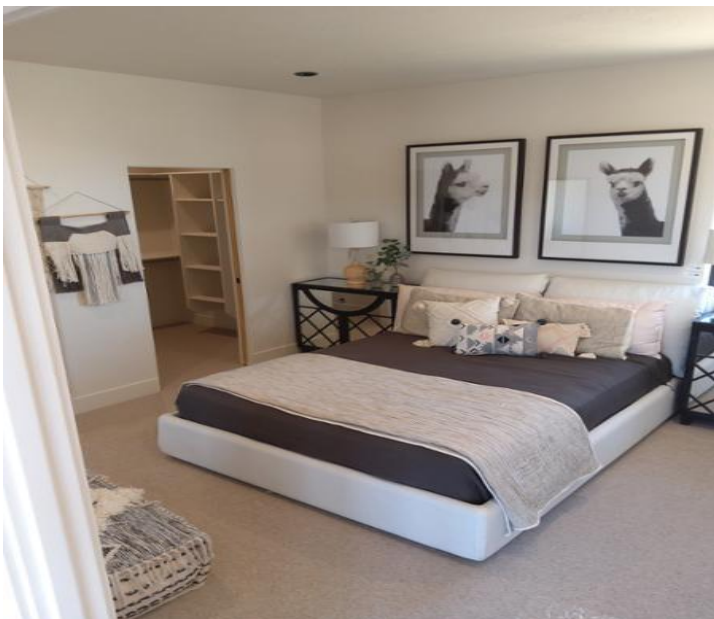
Photo of Bedroom #2.

**Comments:** No issues were observed at the time of the inspection.

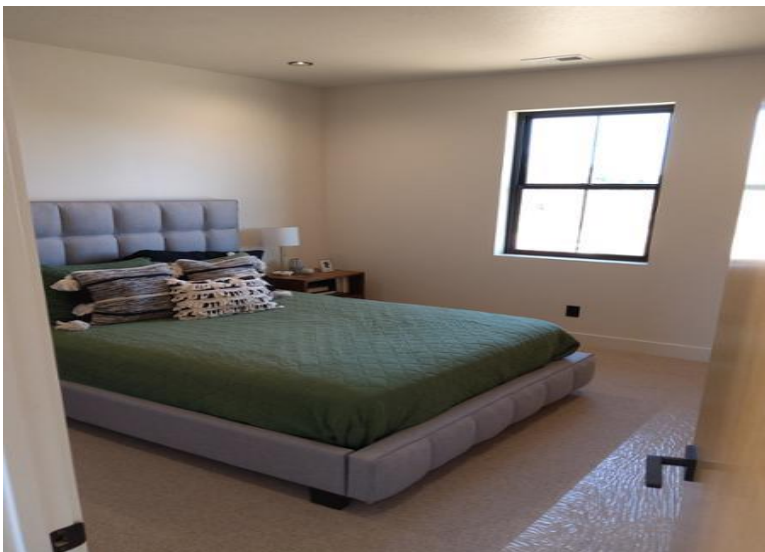
Photo of Bedroom #3.

<b>Location:</b>	Bedroom #3 is located next to bathroom #2 on the second floor.
<b>Type:</b>	BEDROOM
<b>Walls &amp; Ceiling:</b>	Satisfactory
<b>Moisture stains:</b>	No
<b>Floor:</b>	Satisfactory
<b>Ceiling fan:</b>	None
<b>Electrical:</b>	Switches: Yes, Operable Receptacles: Yes, Operable Open ground/Reverse polarity: No
<b>Heating source present:</b>	Yes
<b>Bedroom Egress restricted:</b>	No
<b>Doors:</b>	Satisfactory
<b>Windows:</b>	Satisfactory
<b>Comments:</b>	No issues were observed at the time of the inspection.
